ATHABASCA, ALBERTA

OLD BRICK SCHOOL

DESIGN DEVELOPMENT REPORT

NOVEMBER 29, 2019 | MANASC ISAAC ARCHITECTS LTD.

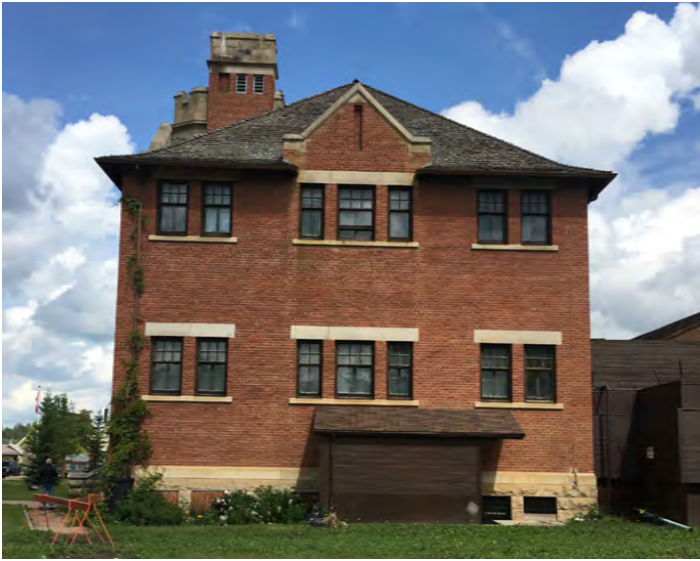
SOUTH ELEVATION

3 - LIMESTONE CORNICE & BATTLEMENTS

The limestone cornice and battlements are located at the top of centrally-located, three storey, red brick tower and air-shafts. These exterior wall details require a cleaning and minimal repair. Such small limestone repairs shall include using a replacement material in kind.

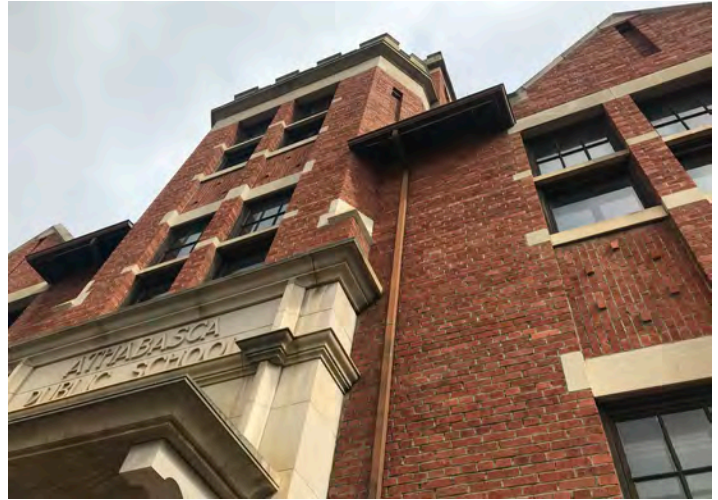
CENTRAL THREE STOREY BELL TOWER & FENESTRATION PATTERN AND WINDOWS ON CENTRAL TOWER

7 / 8 - CENTRAL THREE STOREY BELL TOWER & FENESTRATION PATTERN & WINDOWS ON CENTRAL TOWER

The central three storey bell tower is an exterior wall character defining element. Made up of predominately brick and limestone, if and when the central three story bell tower needs to be repaired, its wall assembly including its functional and decorative elements are to be retained. Currently, the elements of the central three story bell tower are in good condition and only require a protective cleaning.

The fenestration pattern of the tower with three small six-paned windows at the first floor level, and pairs of nine over one windows on the upper two levels are a 'windows' character defining element. This is the only occurrence of an atypical type of window. These are the three square windows above the main entrance. All the windows, typical or atypical in their properties, operation and characteristics including their form and materials must be retained in their restoration intervention. The majority of the windows need to be replaced, where only a handful can be restored. Both a restoration and replacement process are necessary for all windows. Replace all the single pane glass with a double pane glass in all windows. Repairing of counterweight systems, and caulking. See window detail in the Design Development Drawing Set, Appendix D.

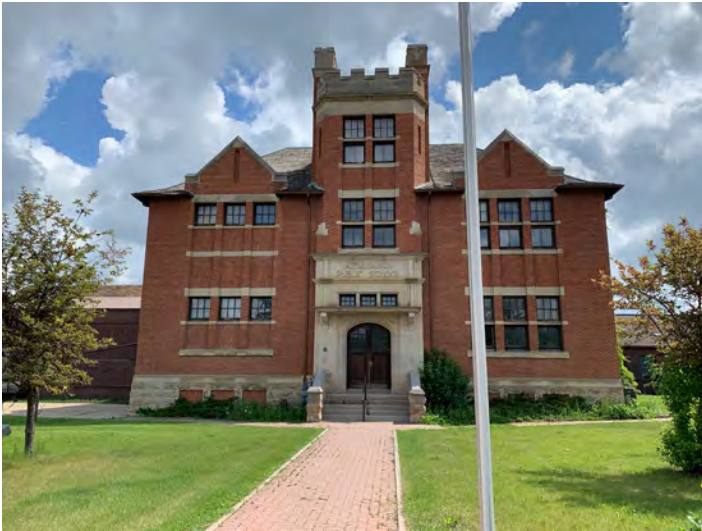
WEST FACADE, FENESTRATION PATTERN & WINDOWS ON PRIMARY ELEVATION

9 - FENESTRATION PATTERN & WINDOWS ON FACADE

The unique fenestration of the primary elevation with regularly spaced nine-over one windows to the south of the central tower and smaller, nine light windows to the north of the tower are a 'windows' character defining element. The windows, in their properties, operation and characteristics including their form and materials must be retained in their restoration intervention. The majority of the windows need to be replaced, where only a handful can be restored. Both a restoration and replacement process are necessary for all windows. Replace all the single pane glass with a double pane glass in all windows. Repairing of counterweight systems, and caulking. See window detail in the Design Development Drawing Set, Appendix D.

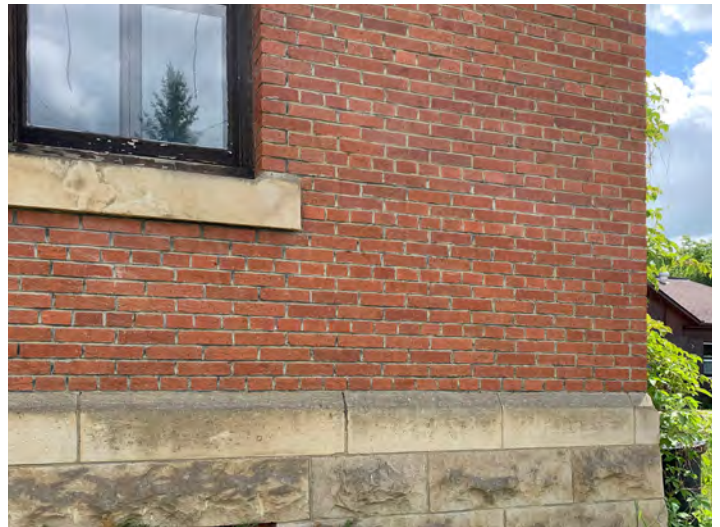
LIMESTONE BELT COURSE & ROUGH FACED STONE FOUNDATION

The limestone belt course between the foundation and the first storey and the rough-faced stone foundation are exterior wall character defining elements. It has been determined that the deterioration of the exterior wall through investigation is quite minimal. Protective measures include maintaining through a gentle cleaning. Any repairing of small cracks or chips in the limestone belt course or rough-faced stone foundation should match the existing work as closely as possible, both physically and visually.

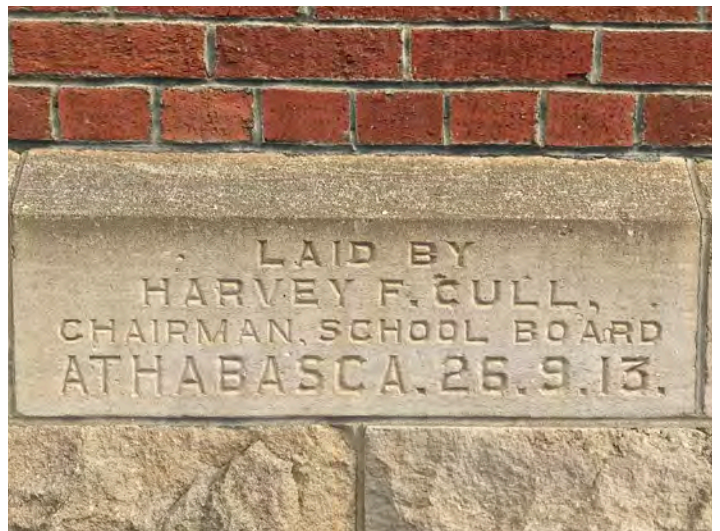
ENGRAVED LIMESTONE BELT COURSE

One stone of the belt course is engraved with the words 'Laid By Harvey F. Cull, Chairman, School Board, Athabasca. 26.9.13.' The stone is in good condition and should be preserved as such.

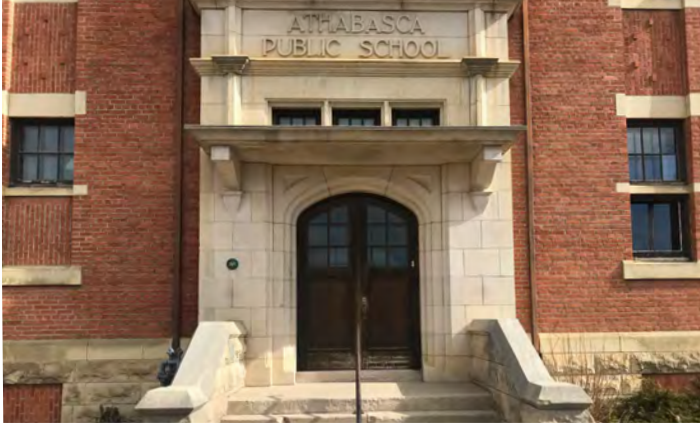
LIMESTONE ENTRY PORTAL

The massive front entry portal, constructed of limestone and situated in the base of the tower, is a exterior wall and building form character defining element. Although robust, the entry portal has experienced graffiti, chipping, and weathering at its base. Preservation methods include; protection through the cleaning and removal of graffiti repairing the chips and cracks by either patching, piecing-in, with materials in kind, as well as with work that, as closely as possible matches the existing work, both physically and visually.

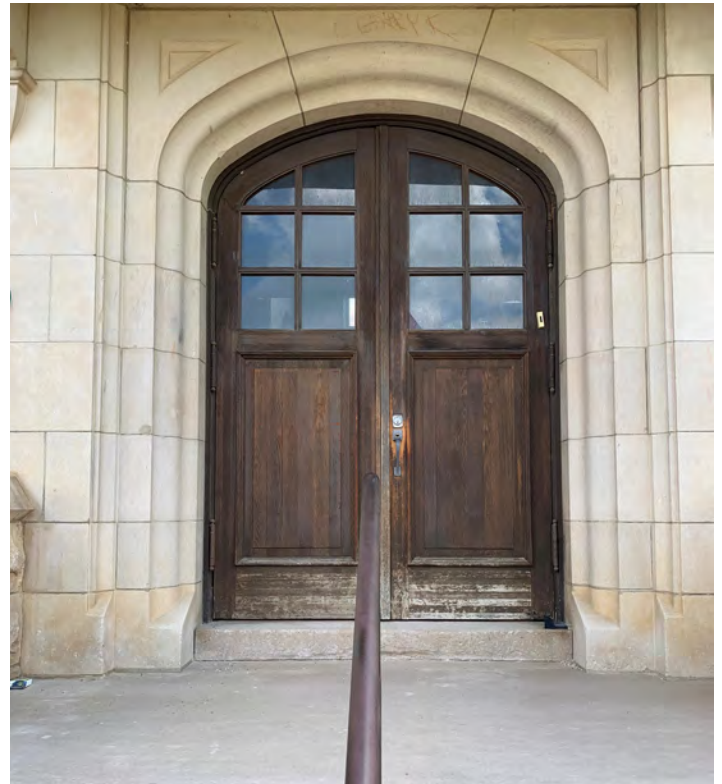
HEAVY WOODEN ARCHED ENTRY DOOR WITH SIX LIGHTS SET WITH IN A TUDOR ARCH

15 - WOODEN, ARCHED ENTRY DOOR

The heavy, wooden, arched entry door with six lights set with in a Tudor arch are a door, is a character defining element. The existing door, although sturdy, has weathered considerably at its base, and requires rehabilitation. Rehabilitation includes removing the door and restoring the wood back to its original condition. Protection of the door must be taken when considering finishes on the restored door. Making the door weather tight, adjusting hardware, sealing openings and joints is imperative while retaining the glazing in the door ensuring that the function, material and decorative elements are consistent with that of the original.

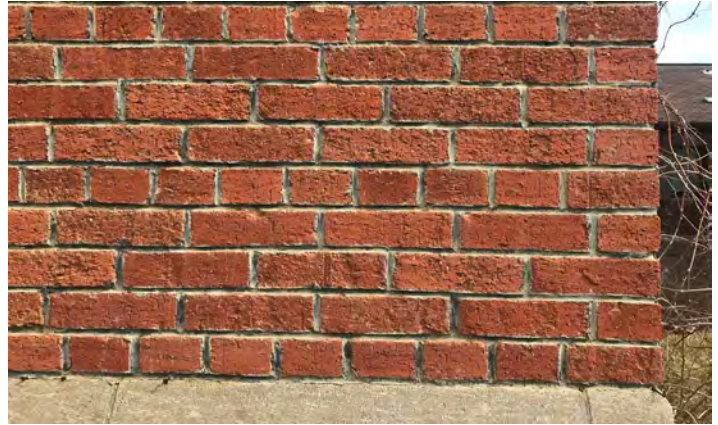
EXTERIOR BRICK

BRICK REPOINTING & CLEANING

The masonry, both the brick and limestone, as character defining elements are to be preserved and in some locations restored. Restoring and preserving the masonry includes, cleaning it, applying appropriate surface treatments, sealing in addition to repointing the brick. Before repointing, removing of deteriorated or inappropriate mortar by carefully raking the joints, while avoiding damaging the masonry is to be undertaken. Repairing the masonry through the repointing, then, where there is evidence of deterioration, such as disintegrating or cracked mortar, or loose bricks, or damp walls, should be completed.

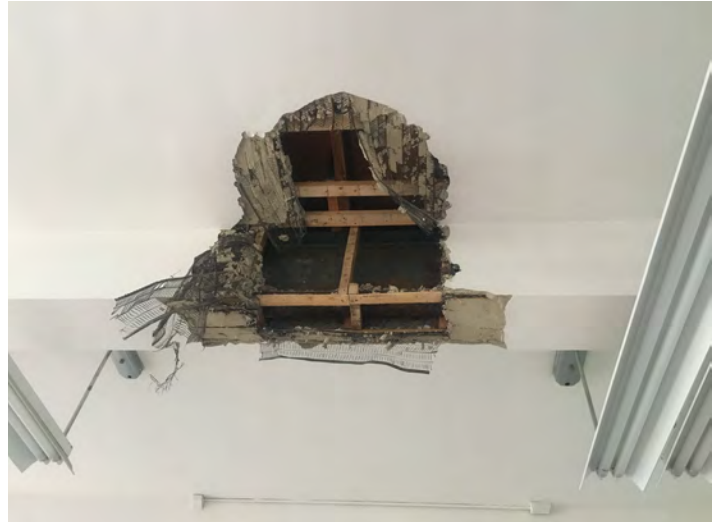
AREA ON THE CEILING TO BE REPAIRED

The ceiling of the Old Brick School will be restored in the areas necessary, including where they have been demolished and/or affected by water damage. The ceiling will be patched (to meet the conservation of the lath and plaster), primed, and repainted to match the existing colour, in kind. Some areas, including the community cafe, will have an ceiling finish that is darker in appearance that what is currently in the space.

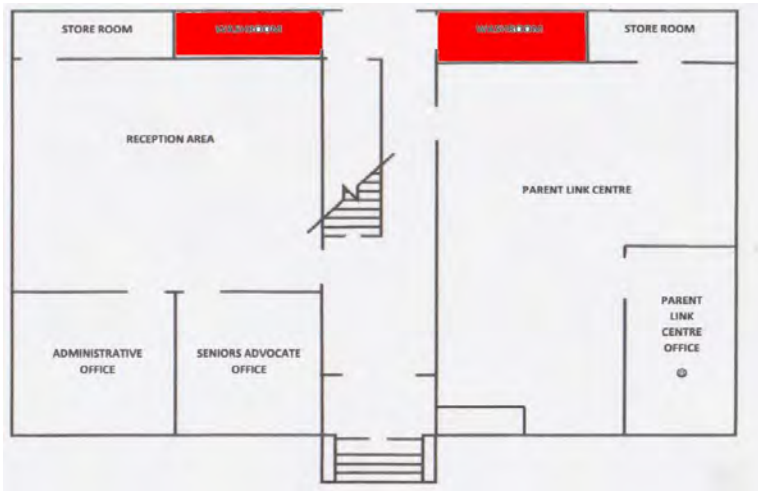
Figure 1. Main Floor, Sheet Vinyl flooring

Locations of the asbestos sheet flooring are shown in **RED**.

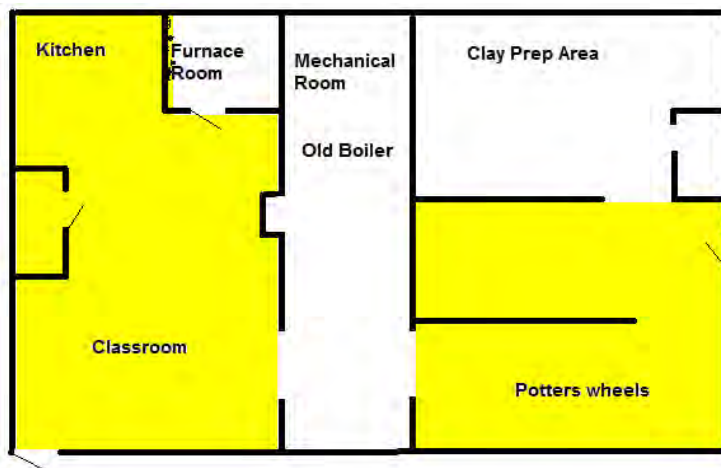
Figure 2. Basement, Floor Tiles

Asbestos-containing vinyl floor tiles (Chrysotile 3%) were present in the basement. Approximate quantity was One thousand two hundred and fifty square feet (1250 ft²). See SAI report #1625262 - samples #14 & #26. Floor tiles were in fair condition at the time of the assessment.

Locations of the asbestos floor tiles are shown in **Yellow**.

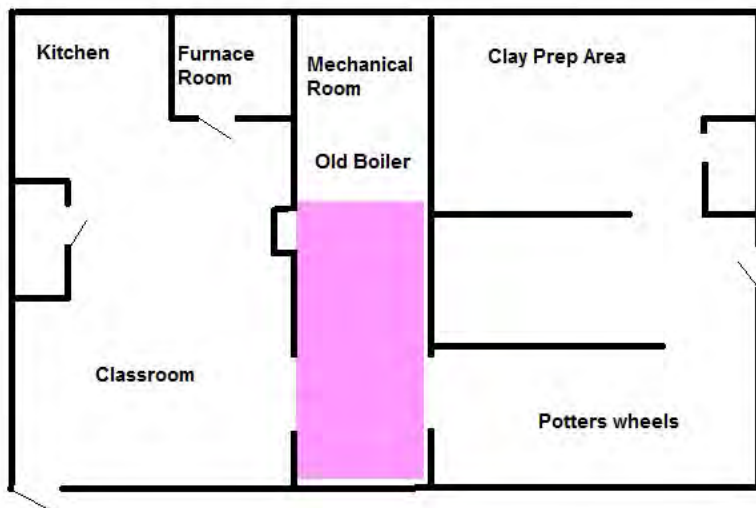
Figure 3. Basement, Cement Ceiling Panels

Locations of the asbestos ceiling panels are shown in Pink.

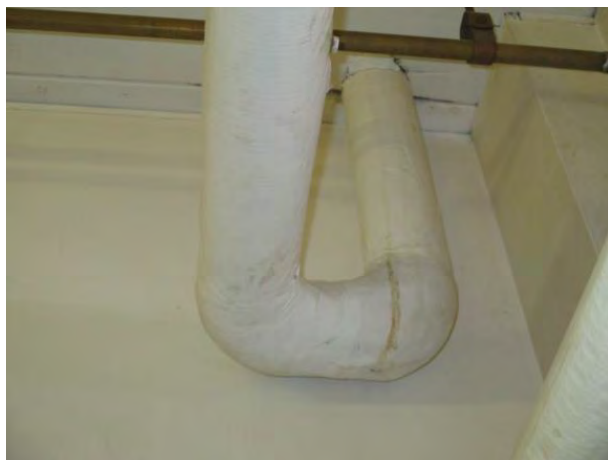
Pipe fitting insulation was present in the basement classroom and furnace room. Additional asbestos-containing insulation can be expected inside wall cavities and chases that were not accessible during the inspection. All cementitious pipe insulation should be treated as asbestos-containing until lab analysis has proved otherwise.

Typical pipe fitting insulation in the basement classroom (Chrysotile 40%).

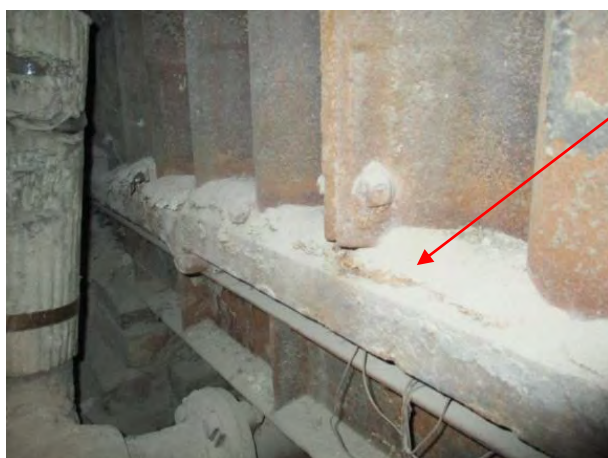
Asbestos-containing insulation and debris (Chrysotile 50%), abandoned pipe insulation (Chrysotile 60%) and grey caulking on the boiler (Chrysotile 8%) were observed in and around the old abandoned boiler in the basement mechanical space. See SAI report #1625262, sample #21-23. The insulation and debris were exposed, in poor condition and very friable (powdery).

The dust and debris was collected from around the fins of the old abandoned boiler.

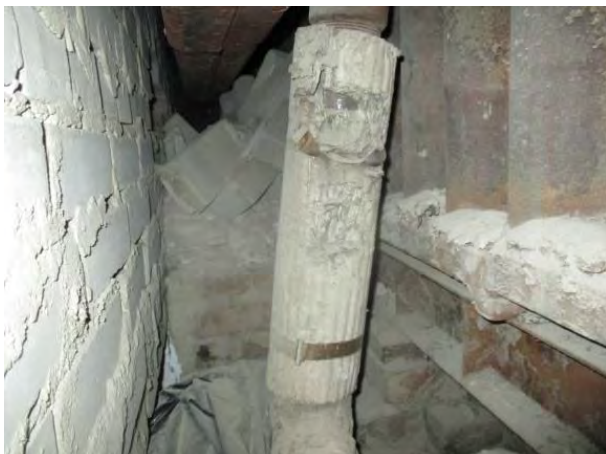
A view looking along the side of the boiler. Fragments of pipe insulation (Chrysotile 60%) and debris were observed on the floor.

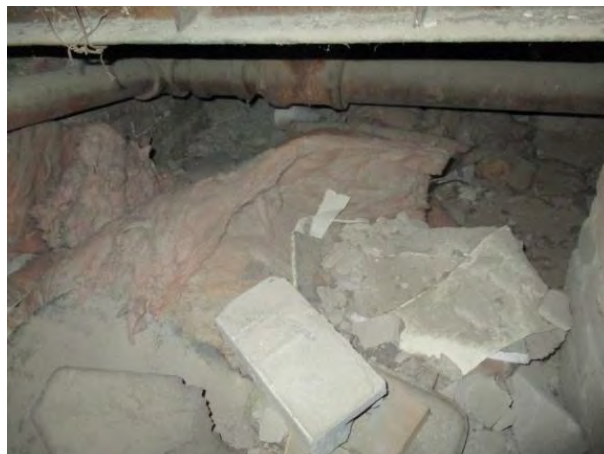
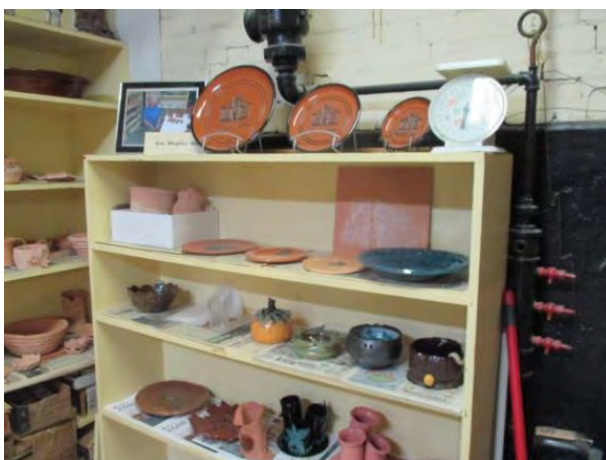
A shelving unit was blocking the front of the boiler. The shelving was not moved due to the risk of accidental pottery breakage. It is common for asbestos-containing gaskets to be present inside and around the boiler doors. This was not confirmed during our assessment. It is also common for asbestos containing materials to be present inside the boiler – not confirmed during the assessment.

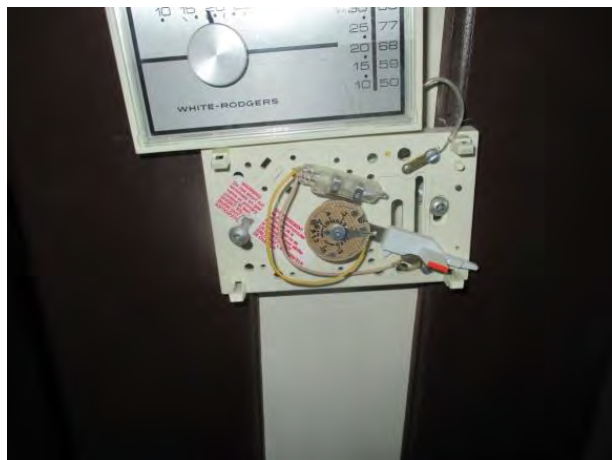
Approximately five (5) thermostat switches containing mercury filled bulbs were identified in the building.

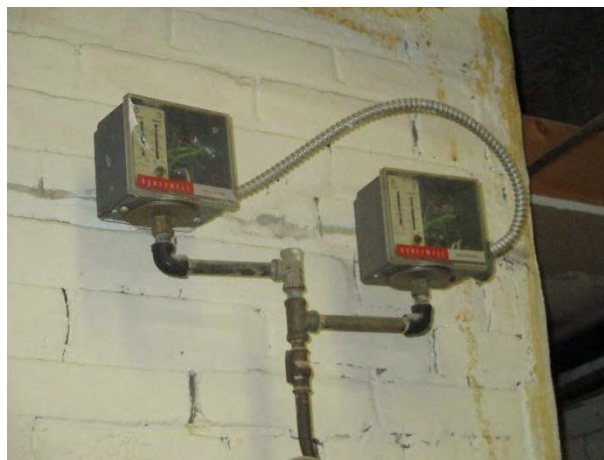
Boiler switches containing mercury filled bulbs were noted. Two (2) were observed.

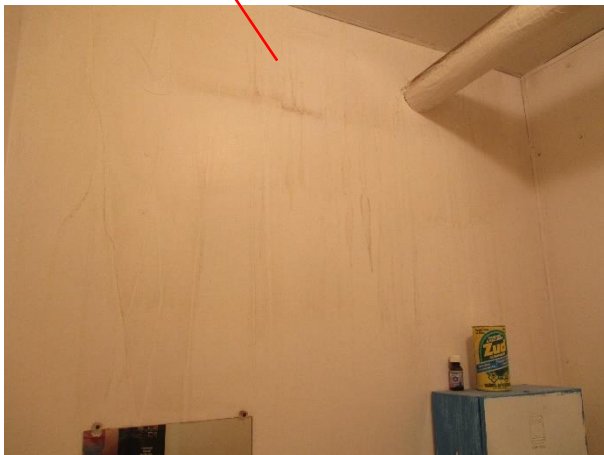
Water staining on bathroom wall. Approximate size of affected area 50 ft².

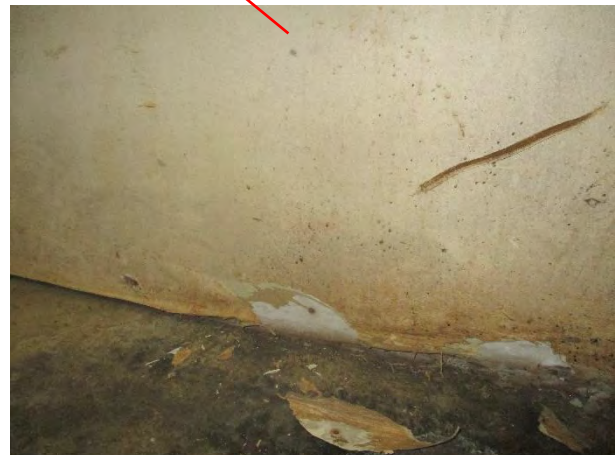
Discolouration and water staining were evident along the bottom of the drywall in the furnace room. Approximate size of affected area 110 ft².

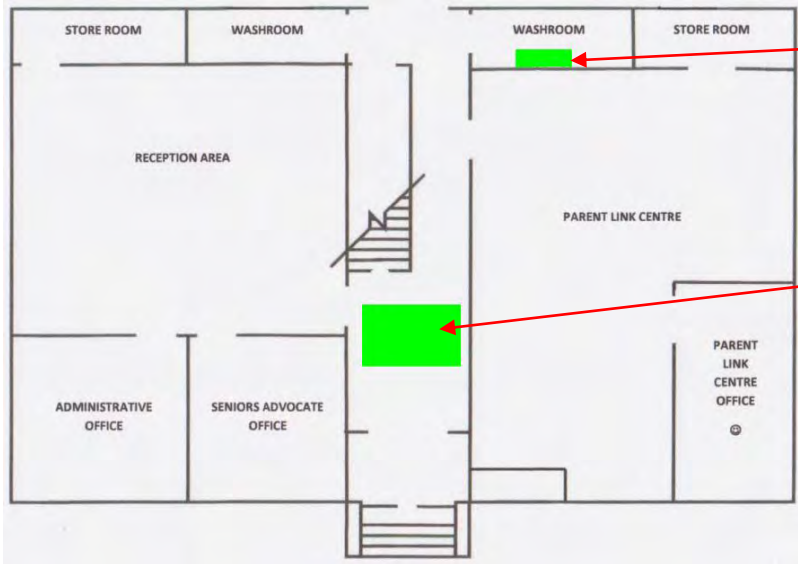
Figure 6. Main Floor, Water Damage

The vanity unit in the washroom had significant water damage and should be replaced.

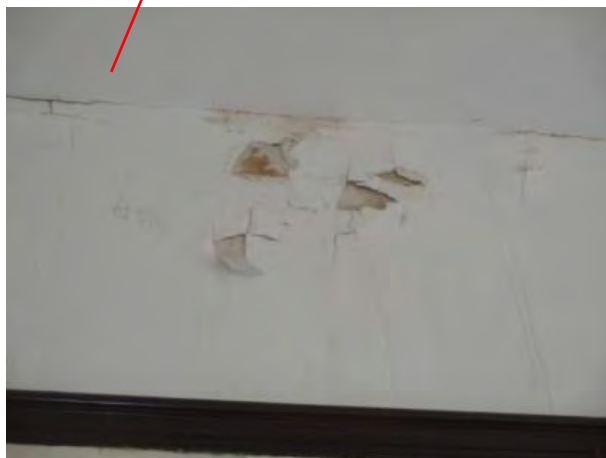
Approximate size of affected area 35 ft².

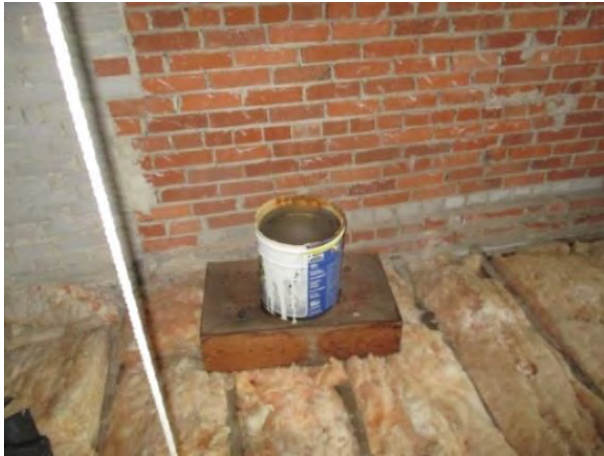
A bucket had been used to catch water drips from a hole in the roof below the bell.

A picture showing the roof top bell and clapper system. A penetration in the roof was allowing water to enter the attic and migrate into the building, evident on both floors.

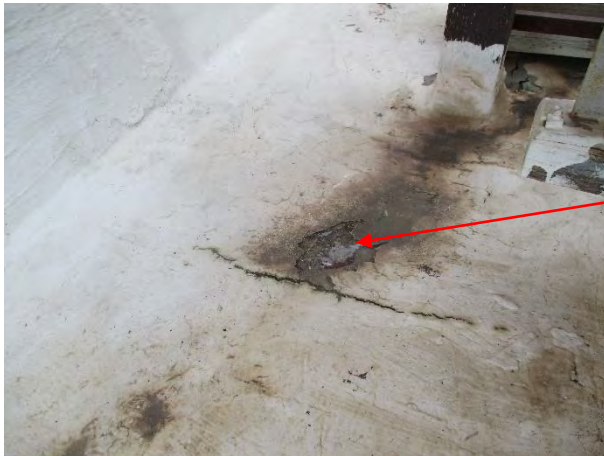
Deteriorated roofing.
